# Service Manual

NISSAN Motor Genuine  
 2DIN HDD Navigation

BOSE Specifications for North  
 America

# ORIGINAL SERVICE MANUAL

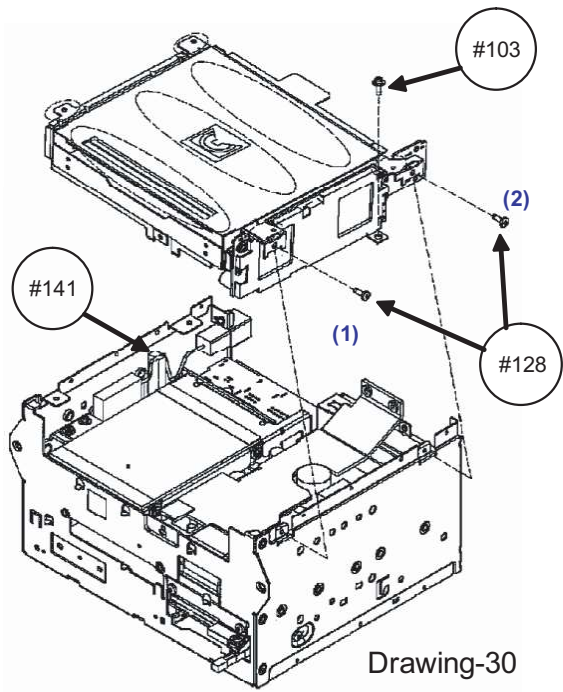
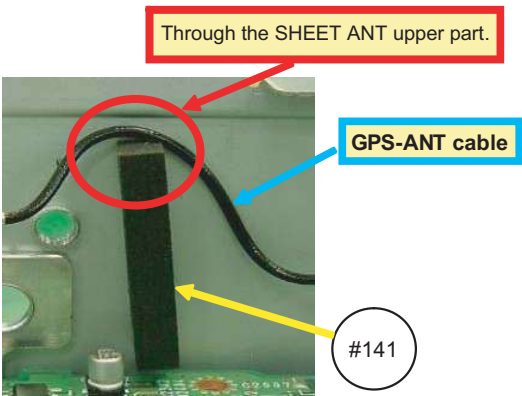
### ASSEMBLY DRAWING

Please confirm it about the additional part (#141) in the following  
ASSEMBLY DRAWING and ASSEMBLY PROCEDUER.

| PROCEDURE | NOTICE |
|---|---|
| 3.Stick the(#141)ANT sheet on the processed<br>AUDIO PWB ASSY (Drawing-30) and<br>lay out GPS-ANT cable. | ※Through the SHEET ANT upper part. (Drawing-24) |

| PAGE | NO. | PART NO. | DESCRIPTION | QTY |
|---|---|---|---|---|
| 10 | #141 | MUZ1971 | ANT sheet (add) | 1 |
