# Service Manual

NISSAN Motor Genuine  
2DIN HDD Navigation

BOSE Specifications for North  
America

# ORIGINAL SERVICE MANUAL

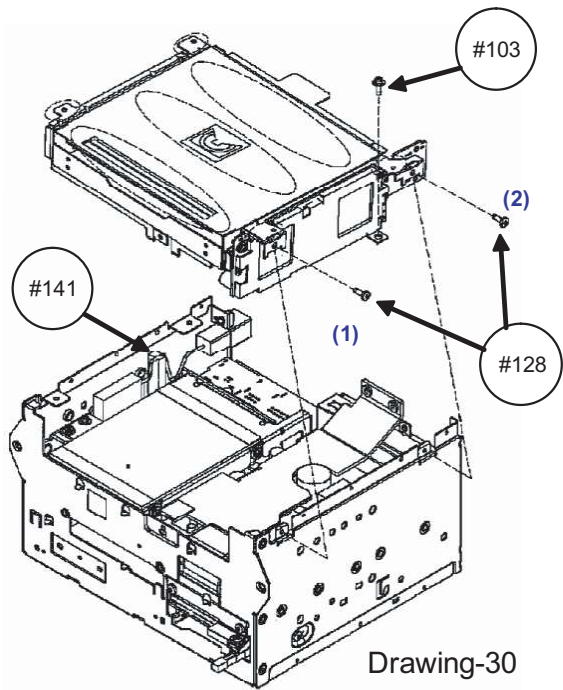
Drawing-30

| PROCEDURE | NOTICE |
|---|---|
| 3.Stick the(#141)ANT sheet on the processed<br>AUDIO PWB ASSY (Drawing-30) and<br>lay out GPS-ANT cable. | ※Through the SHEET ANT upper part. (Drawing-24) |

Please confirm it about the additional part (#141) in the following  
ASSEMBLY DRAWING and ASSEMBLY PROCEDURE.
